**DRAFT FINAL SITE INSPECTION WORK PLAN, PRELIMINARY ASSESSMENT,  
OTHER AREAS/UTILITIES, VOLUME 3 OF 3 - 26 SITES**

**DRAFT FINAL  
SITE INSPECTION WORK PLAN: PA OTHER AREAS/UTILITIES  
VOLUME III OF III: 26 SITES  
NAVAL STATION TREASURE ISLAND  
HUNTERS POINT ANNEX  
SAN FRANCISCO, CALIFORNIA**

**DEPARTMENT OF THE NAVY  
WESTERN DIVISION  
NAVAL FACILITIES ENGINEERING COMMAND  
SAN BRUNO, CALIFORNIA 94066-0727**

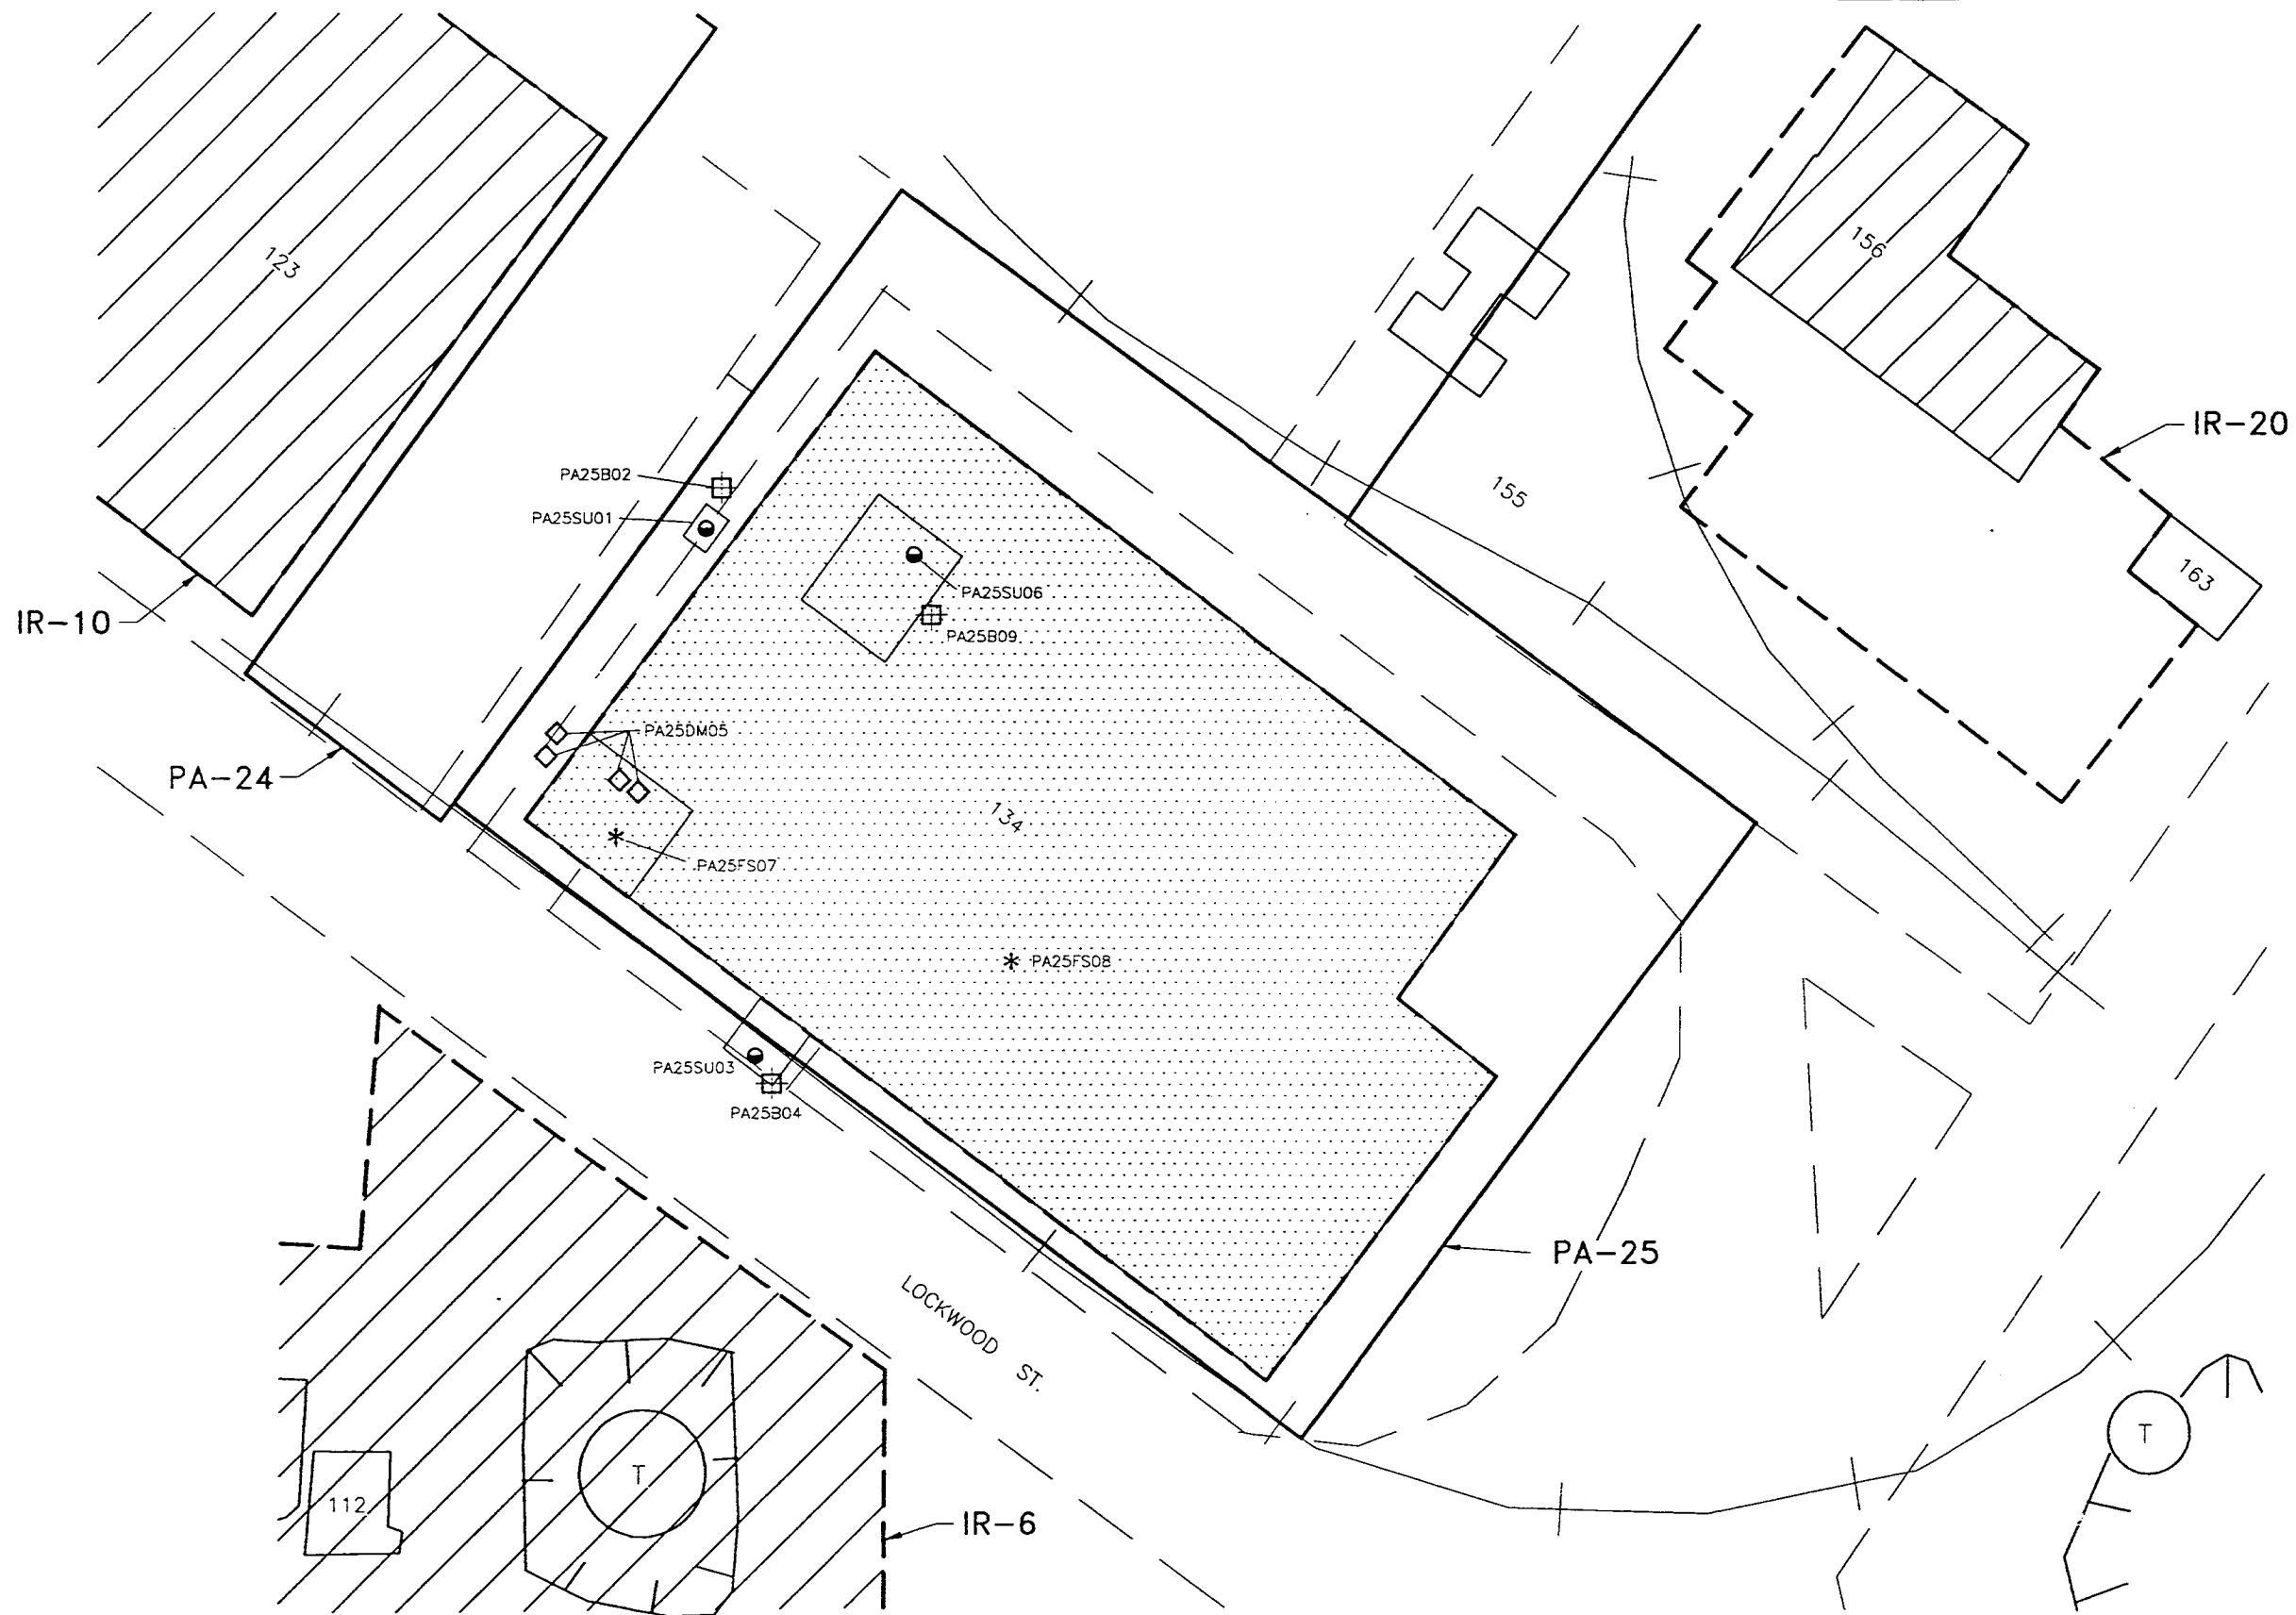
A large concrete dip tank/degreasing vat labeled "chlorinated materials" built into the foundation drains to a sump that is partially inside and partially outside the building. The tank contains sludge, and the sump contains liquid. Pools of standing oil were observed on the concrete floor near and under machines. The floor tile in one machine room is saturated and deformed by apparent oil and corrosive material.

Sampling Location	Sample Designation	TPH	TOG	PCB	VOC	SOC	MTL	OTHER
Outside Sump #1	PA25SU01	1	1	1	1	1	1	
Soil beneath Sump #1	PA25B02	2	2	2	2	2	2	
Outside Sump #2	PA25SU03	1	1	1	1	1	1	
Soil beneath Sump #2	PA25B04	2	2	2	2	2	2	
Composite of 4 55-Gal Drums	PA25DM05	1	1	1	1	1	1	
Dip Tank/Degreasing Vat	PA25SU06	2	2	2	2	2	2	
Stained Tile	PA25FS07	1	1	1	1	1	1	
Machine Shop Oil Composite	PA25FS08	1	1	1	1	1	1	
Soil adjacent to dip tank	PA25B09	1	1	1	1	1	1	
TOTAL ANALYSES		12	12	12	12	12	12

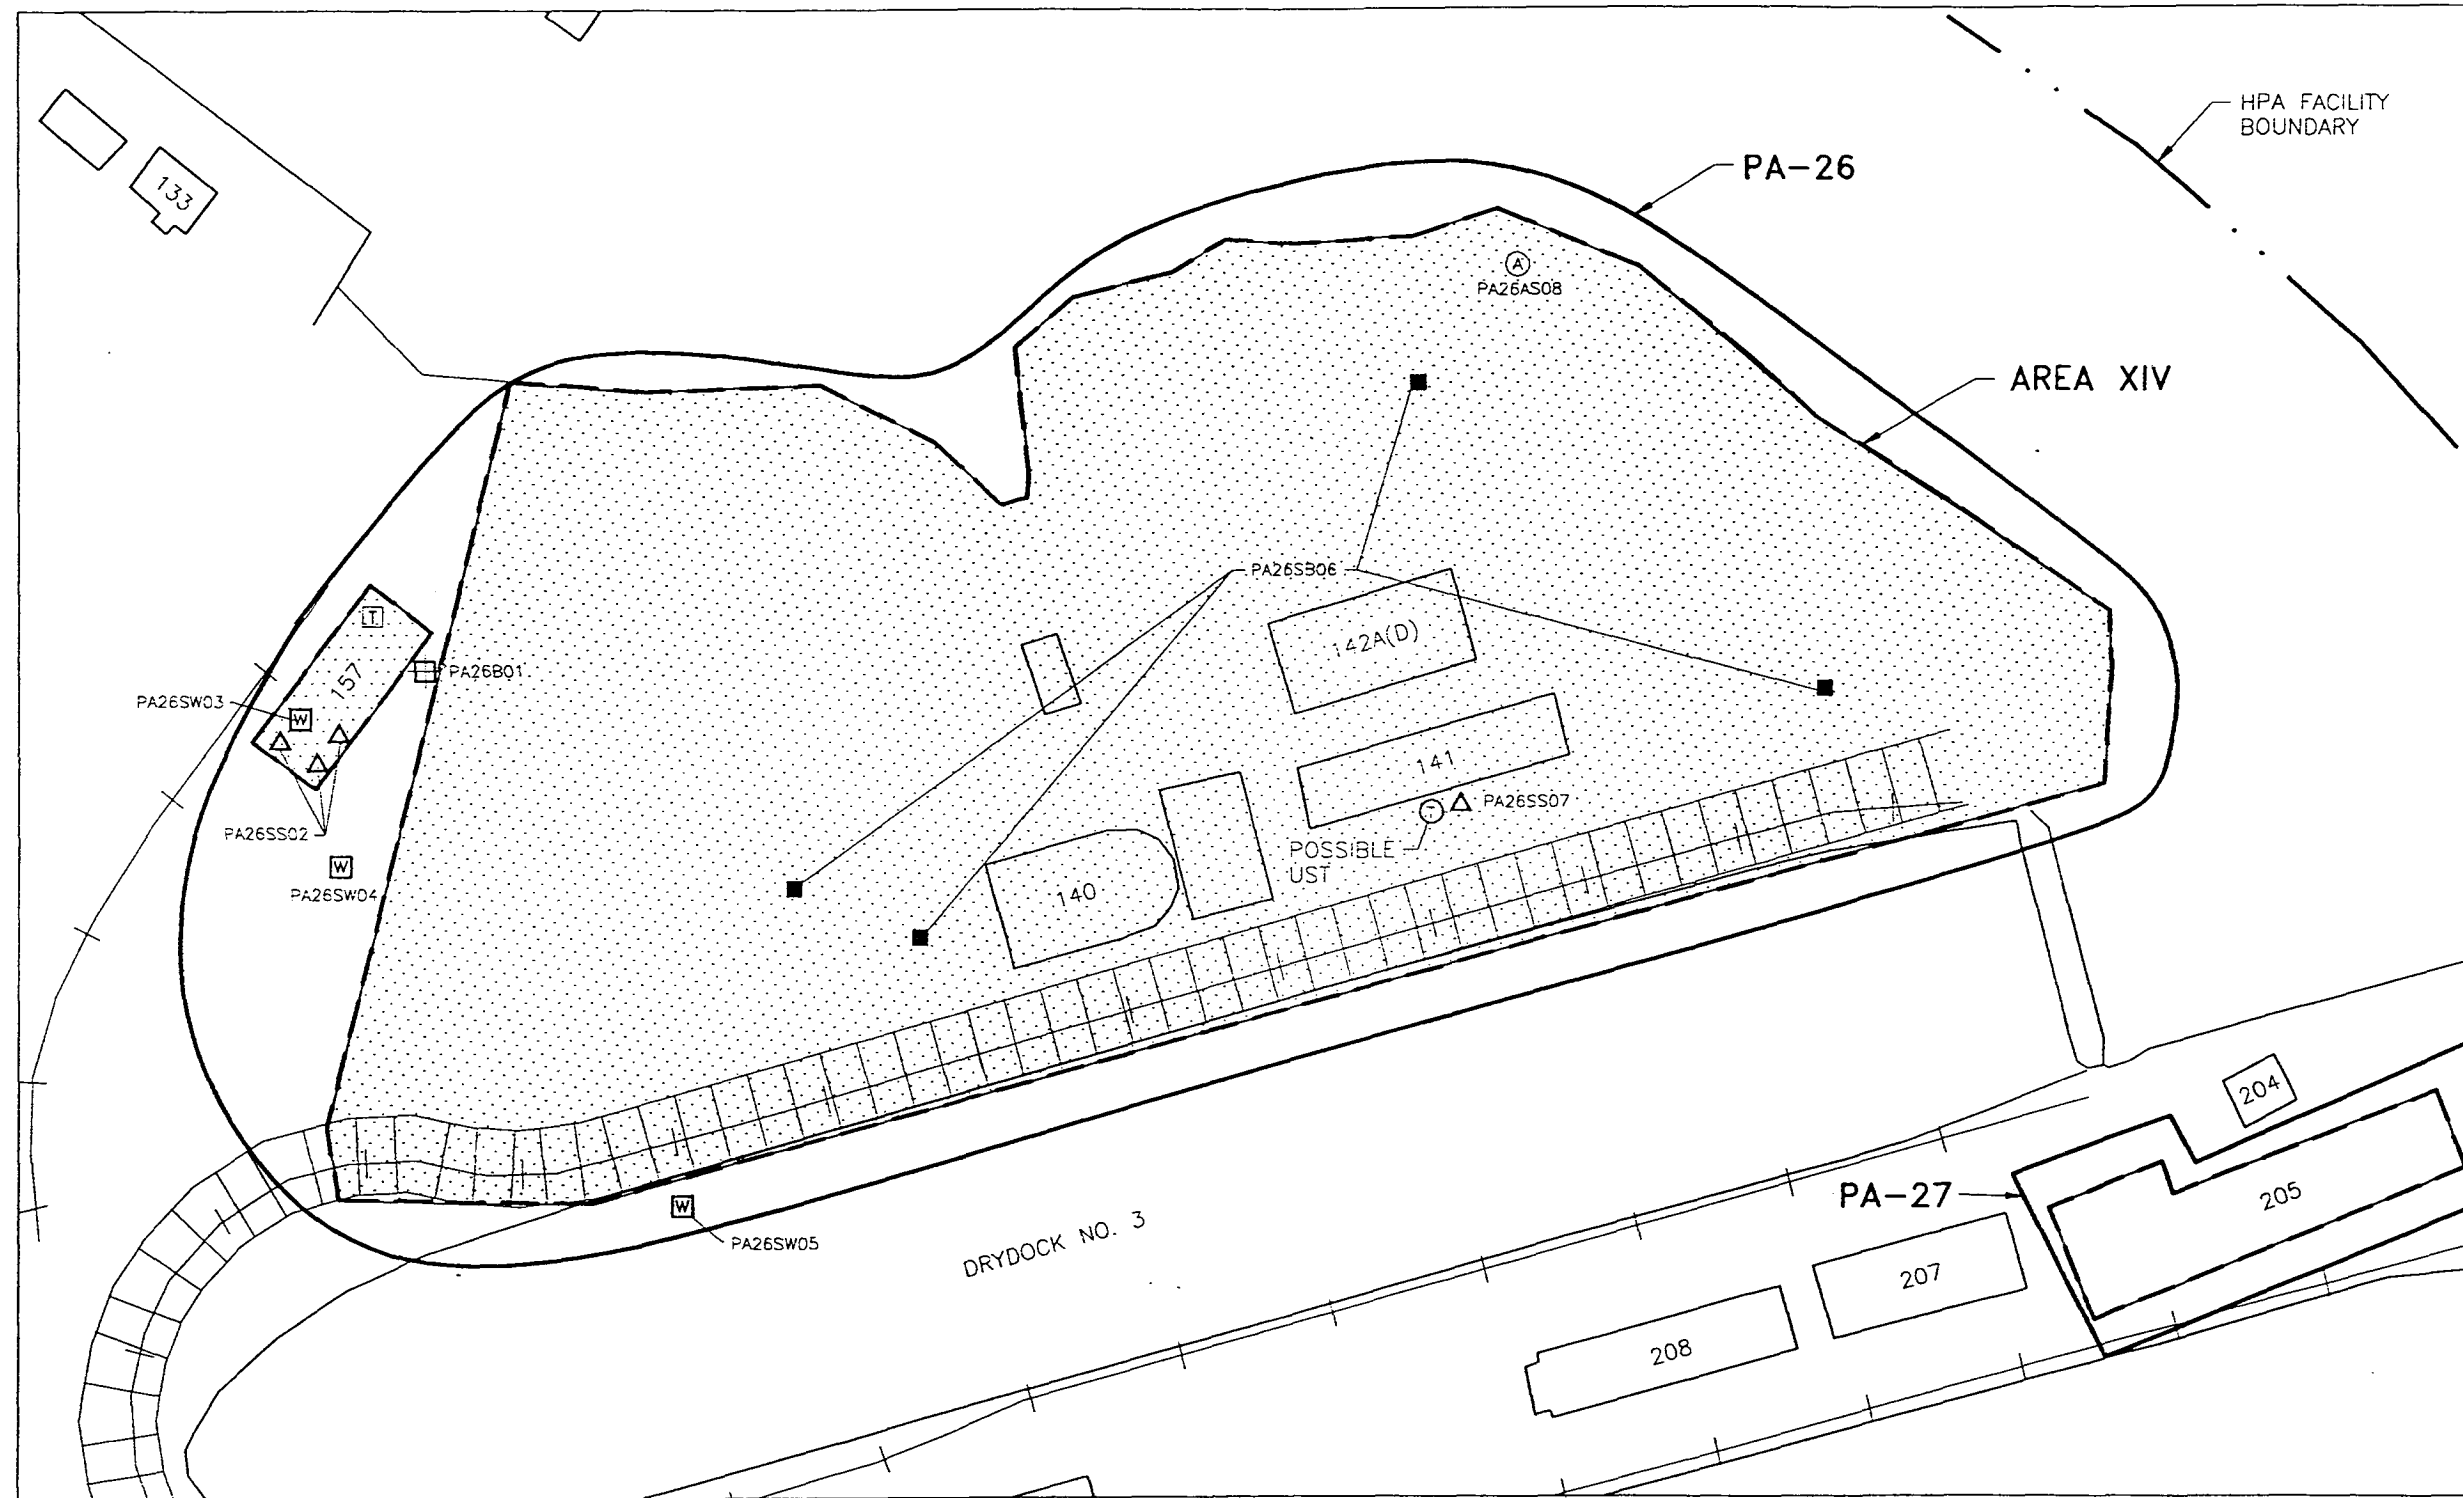
The interior of the building is covered by a concrete and asphalt floor. A thin veneer of soil covers the asphalt and a storm drain is located near the center of the asphalt area where some staining was observed on the soil. A workbench area with a small fumehood is on the southeast wall. An overturned drum surrounded by stained soil and oily sludge is outside the building on the southeast side.

<u>Sampling Location</u>	<u>Sample Designation</u>	<u>TPH</u>	<u>TOG</u>	<u>PCB</u>	<u>VOC</u>	<u>SOC</u>	<u>MTL</u>	<u>OTHER</u>
Storm drain	PA26SW04	1	1	1	1	1	1	CN
Storm drain	PA26SW05	1	1	1	1	1	1	CN
Sandblast material composite	PA26SB06					1	1	CN
Surface soil under wood treatment cylinder	PA26SS07	1	1	1	1	1	1	PCP
Soil near suspected asbestos material	PA26AS08							A
TOTAL ANALYSES		3	3	3	3	4	4

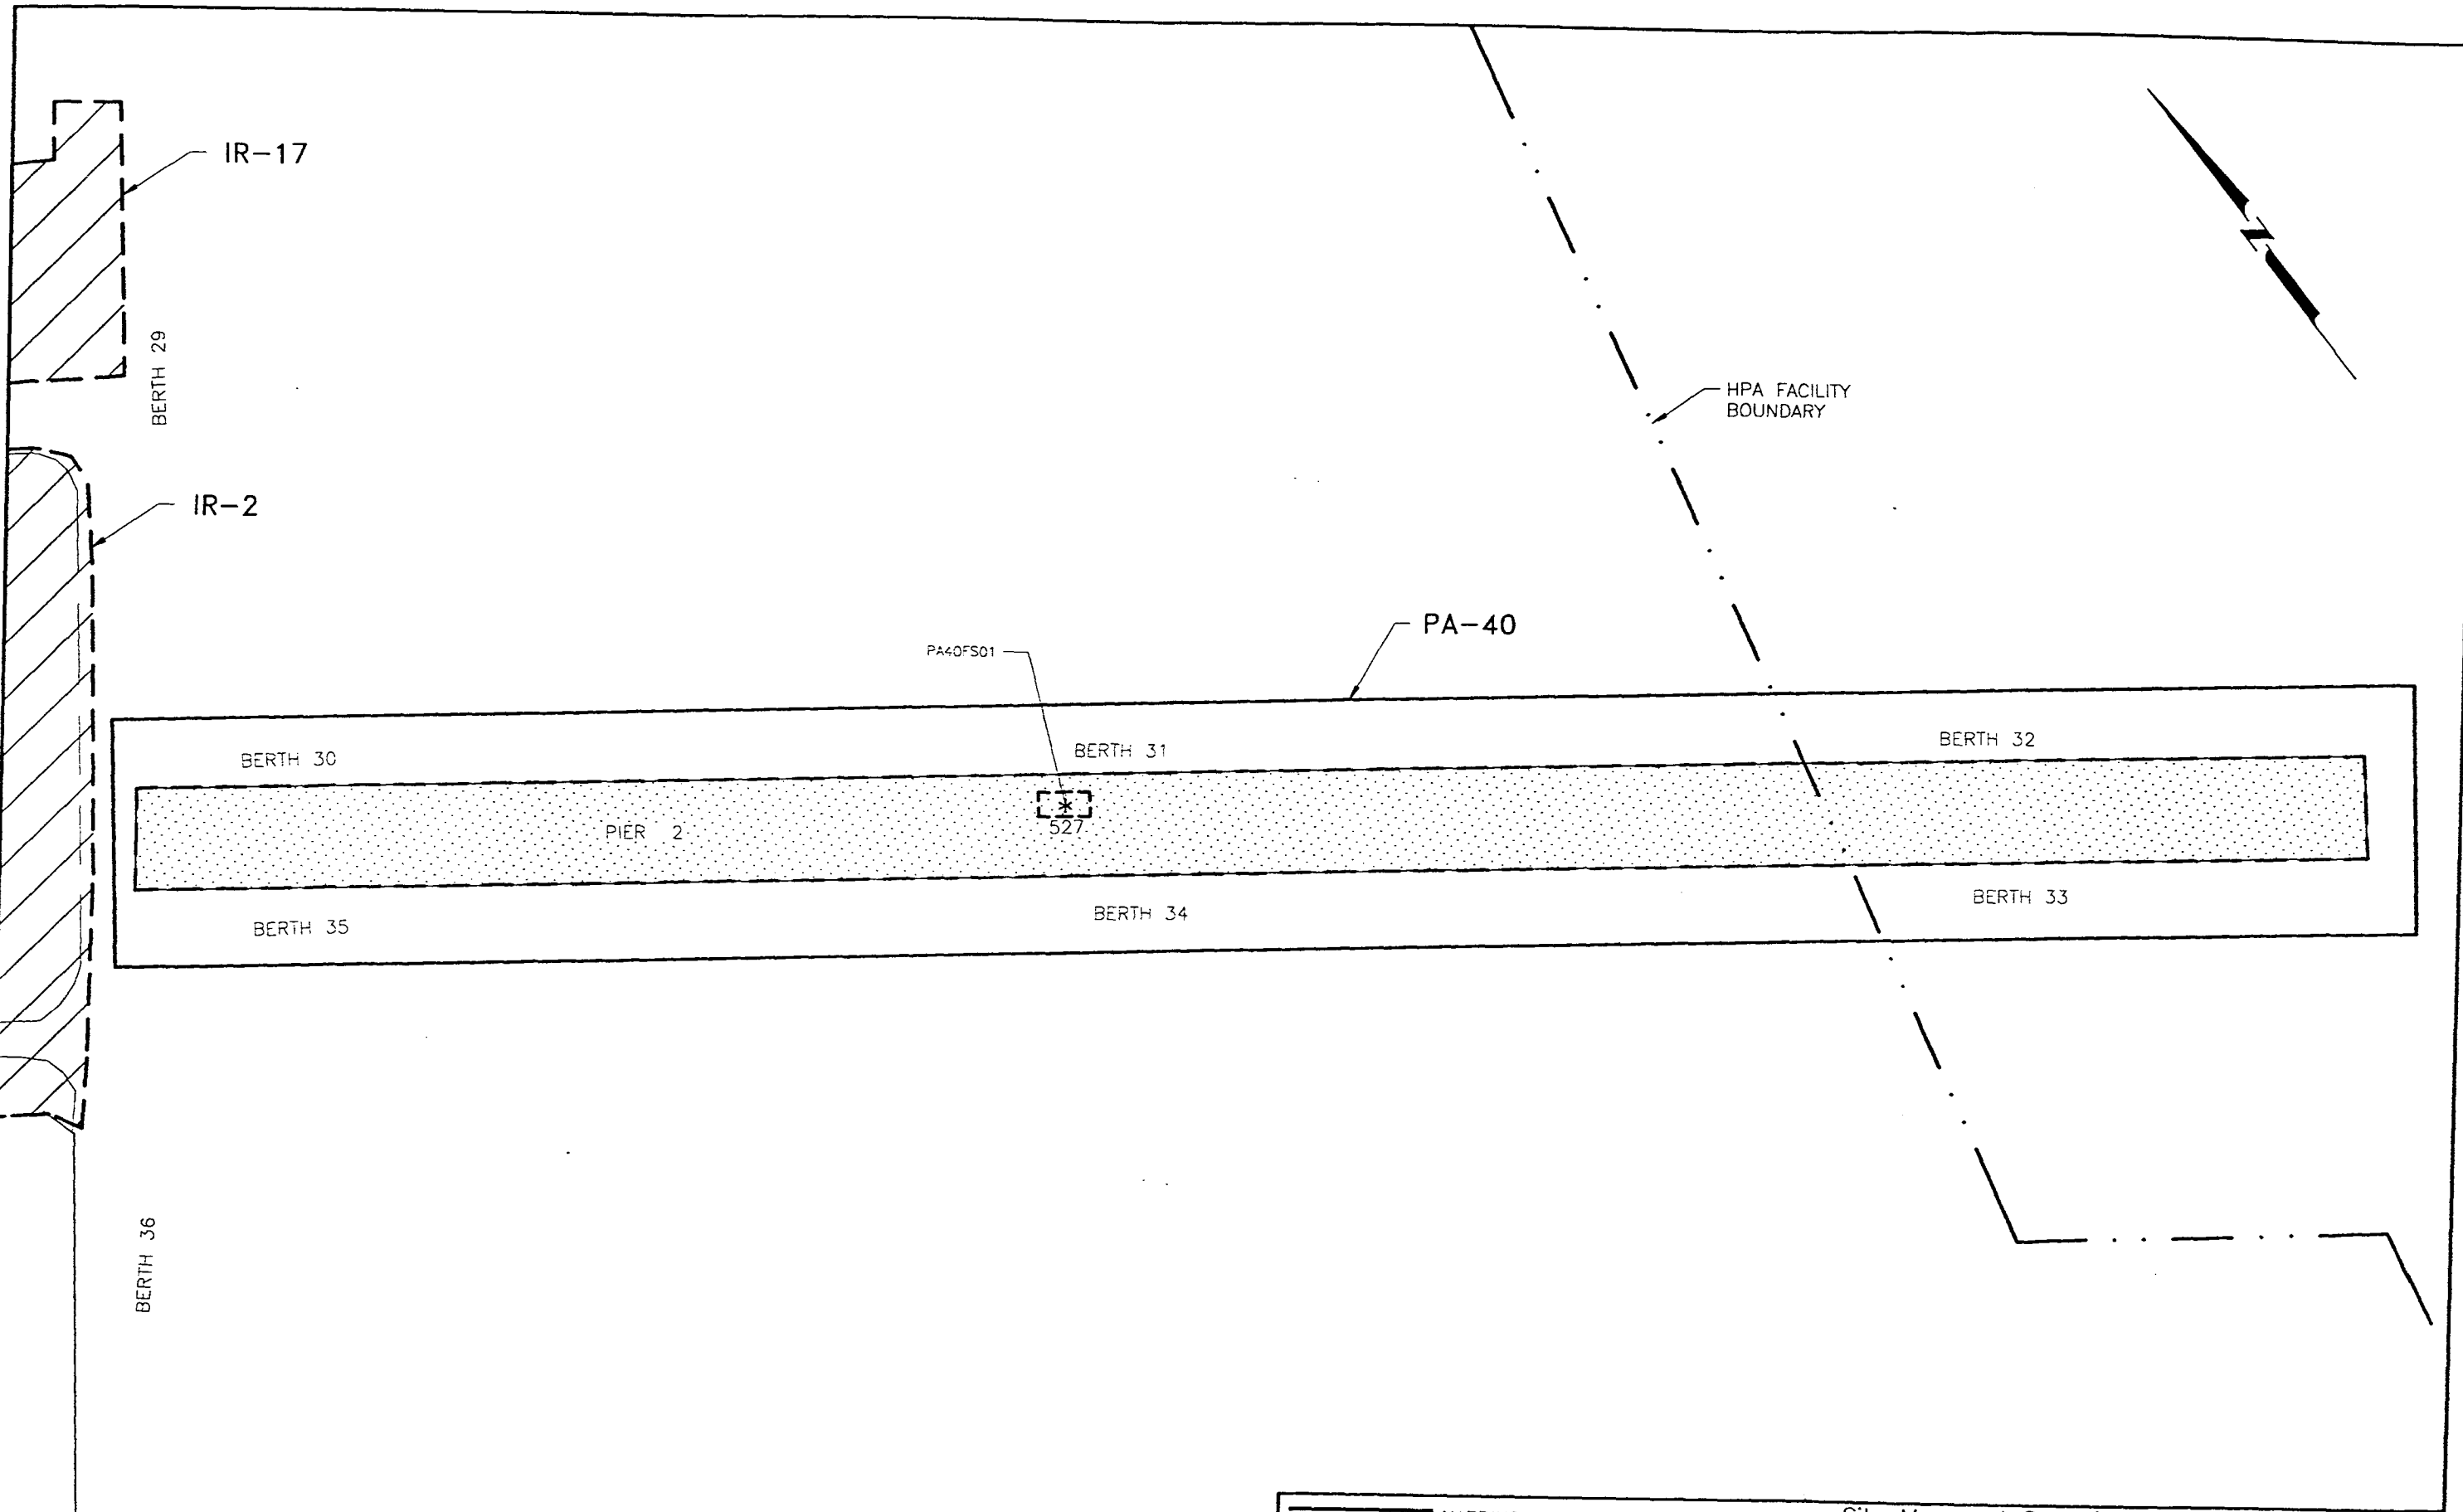
Several 55-gallon petrochemical drums were present on the south side of Building 527. Five- and 10-gallon containers of petrochemicals were also present between Berths 34 and 35. The entire pier is over water and covered with asphalt. No significant stains or other problems were identified on the pier. Utility lines under the pier may pose an environmental threat to Bay water depending on their contents and integrity. No sampling is recommended; however, storage containers should be properly labelled identifying their contents and stored appropriately if hazardous.

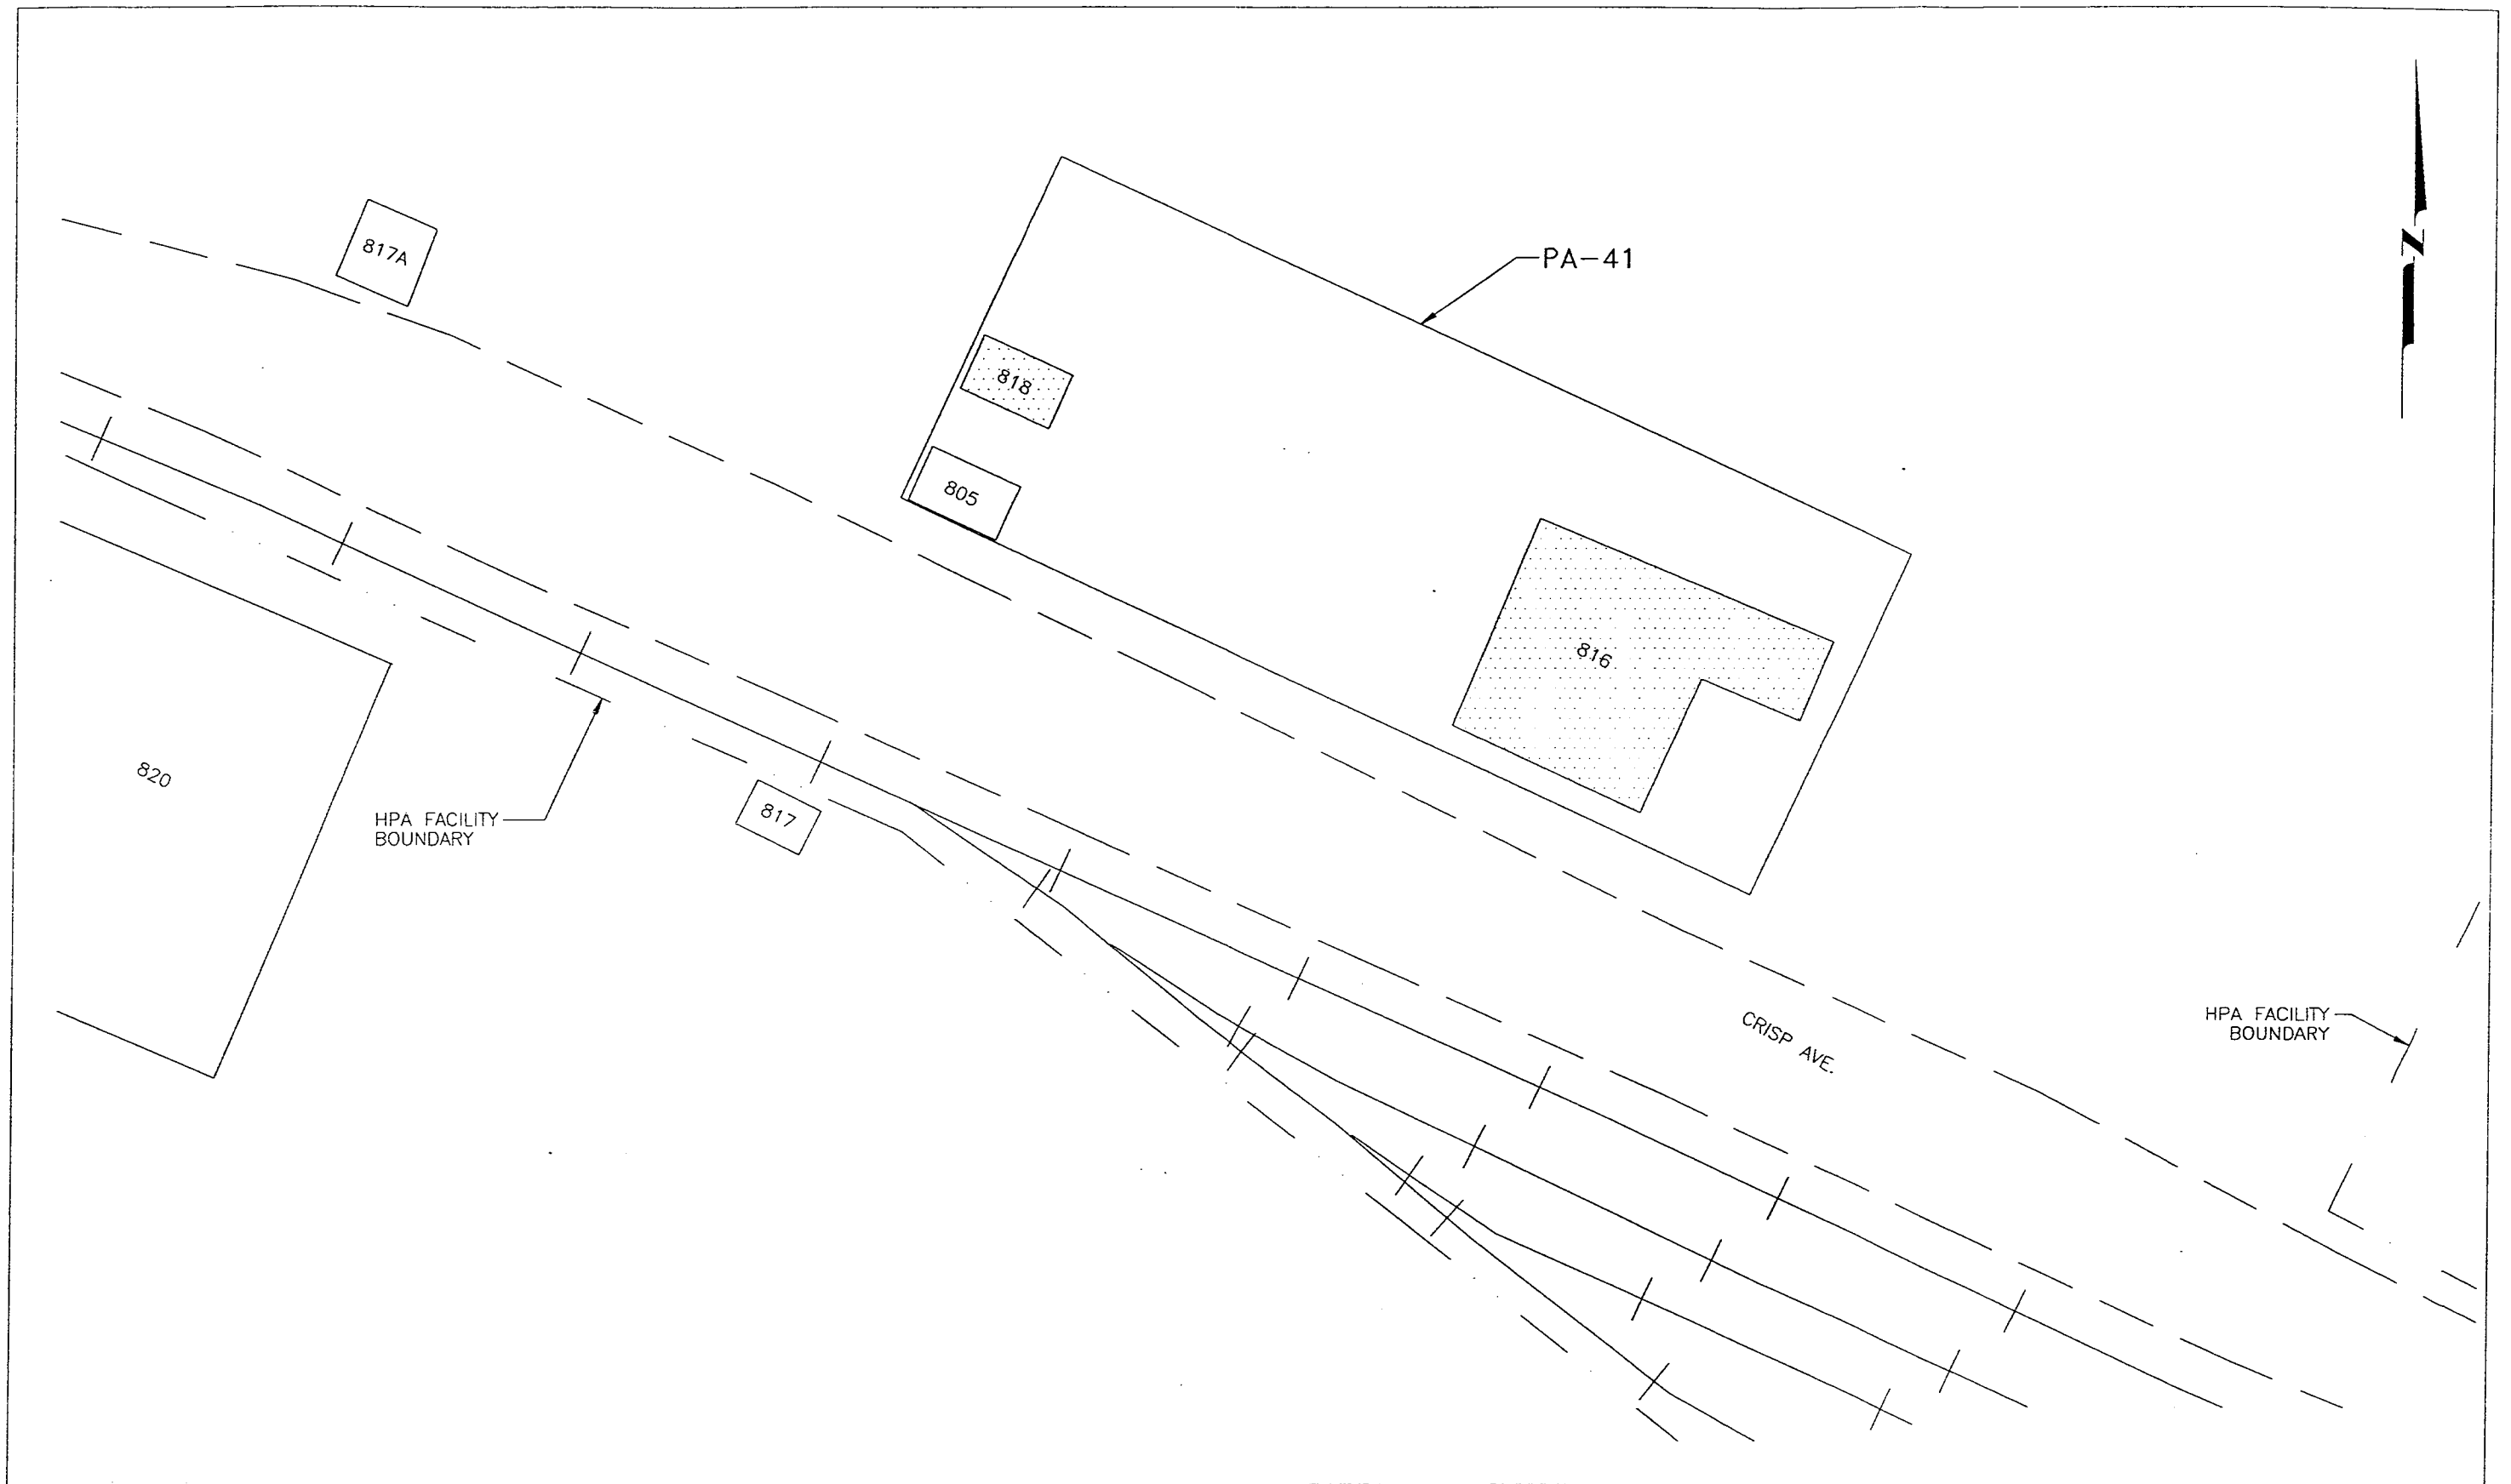
HARDING LAWSON ASSOCIATES Engineering and Environmental Services		Site Map and Sampling Locations Site Inspection Work Plan: PA-41 Hunters Point Annex San Francisco, California		PLATE
	DRAWN PCB	JOB NUMBER 11400 0506	APPROVED CNA	DATE 11/91	REVISED DATE 3/92

This is a small shack with a concrete foundation. A 1971 HPA map (*HLA, 1990b*) shows a circle adjacent to the shack, which is assumed to be a chlorine tank for water treatment. The tank is now gone. No indications of nearby soil impacts were observed. No sampling is recommended.
